Re: Village of Cambridge, Wisconsin
Pedestrian Trail Crossing

Introduction

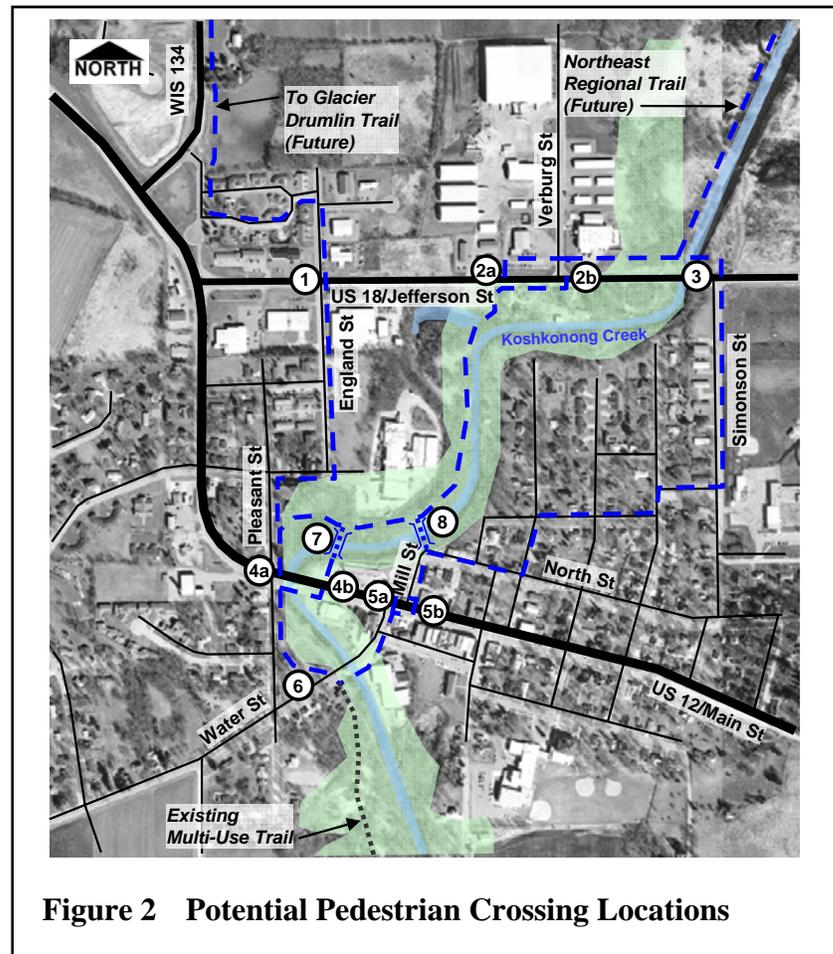
Six roadway and two creek pedestrian/bicycle crossing locations were examined as part of this study. Each location is described in this section, noting its potential for grade separation, connectivity, and utilization of existing structures. The location of each of the crossings is shown in Figure 2.

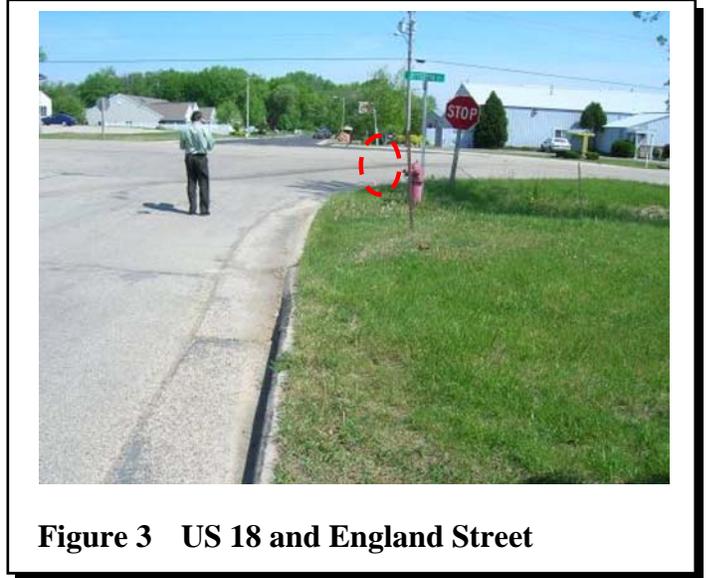
Figure 3 US 18 and England Street

This is a potential north-south pedestrian crossing at US 18 and England Street. The picture in Figure 3 was taken from the south approach of the intersection, looking north.

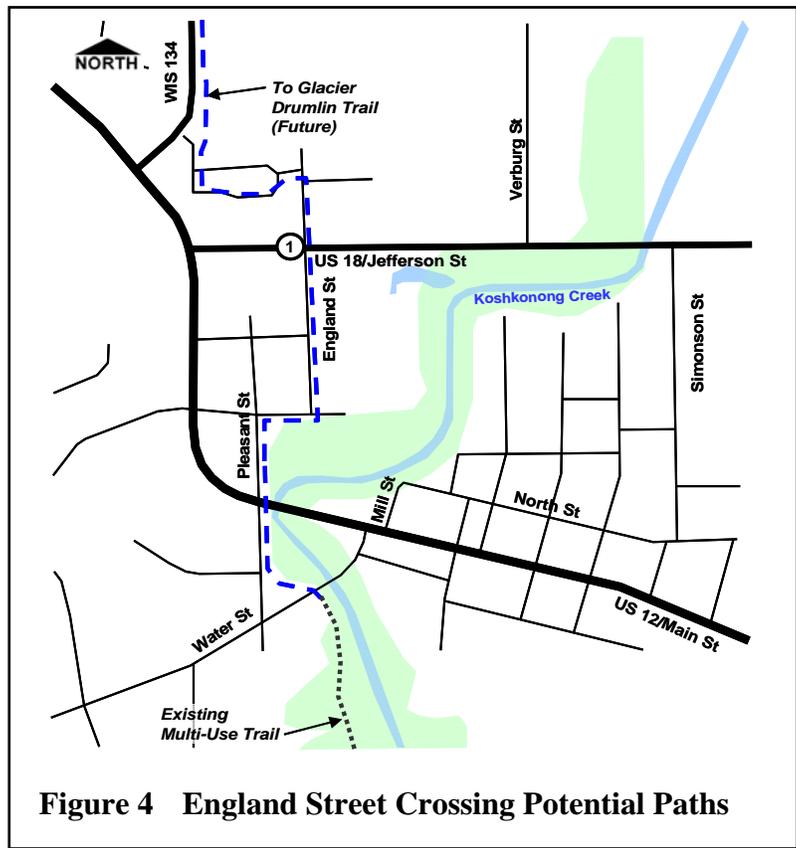
Figure 4 England Street Crossing Potential Paths

This crossing provides a west side connection between the existing southwest Multi-Use Trail and the northwest quadrant of the Village (shown in Figure 4) and would be the closest to the Glacier Drumlin Trail, located to the north of the Village of Cambridge. This location also provides a convenient connection across US 18 for the nearby elderly housing complex.

Currently, there are no pedestrian facilities on any of the approaches of this intersection. On-street bike lanes and off-street bike path and/or sidewalks could be provided on England Street. On-street lanes would require restrictions for on-street parking on England Street. Off-street improvements would result in short-term disruption to the public terrace areas in front of the adjacent parcels.

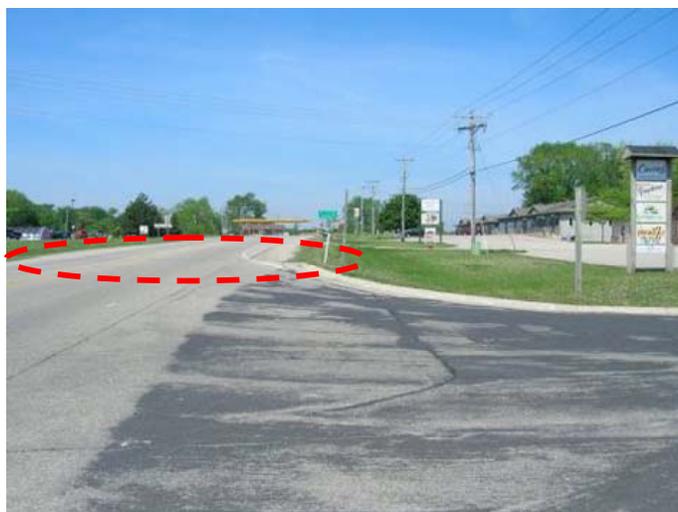
Figure 5 US 18 and England Street Below-Grade Crossing Location

Such a crossing sited on the west approach would consist of a 10-foot x 10-foot precast concrete box structure across US 18 (shown in Figure 5) with approach ramps configured to meet the American with Disabilities Act (ADA) requirements.

To accommodate this structure, existing utilities along US 18 including sanitary sewer, water main, gas, and telephone would need to be relocated. In addition, storm sewer and drain tile from the structure

subgrade would also need to be provided to maintain current ditch line drainage patterns and to provide positive subgrade drainage for the structure.

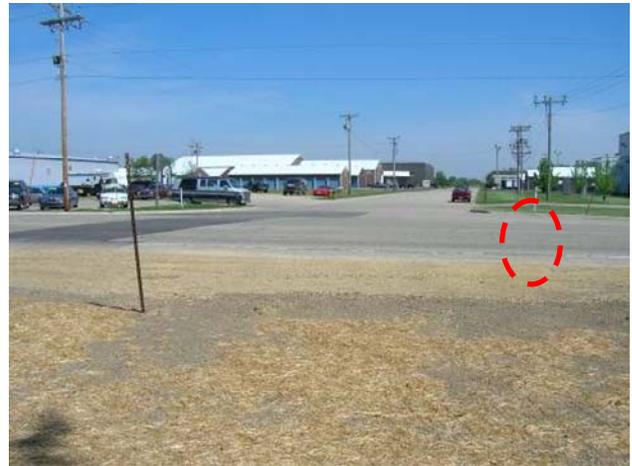
Figure 6 US 18 and Verburg Street East Crossing Option Location

There are two potential north-south pedestrian crossing options near US 18 and Verburg Street. The picture in Figure 6 was taken from the south side of the intersection, facing north. There is also an option for a crossing approximately 300 feet to the west of this intersection as shown in Figure 7.

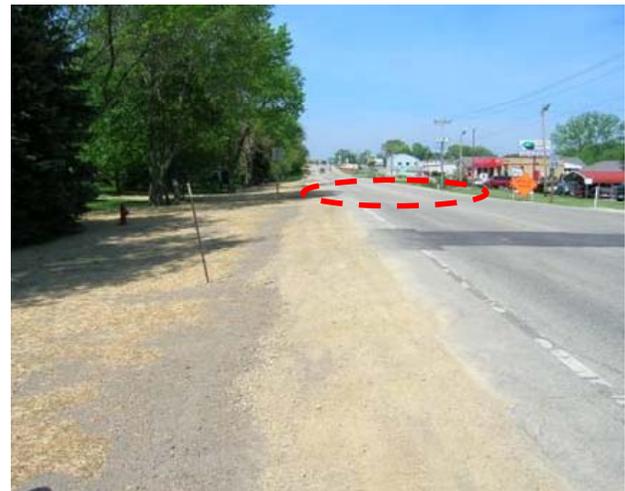
Figure 7 US 18 and Verburg Street West Crossing Option Location

The westerly option provides a somewhat more direct route from the future path location along the west bank of Koshkonong Creek. The easterly crossing should be at the east approach of the intersection. For an at-grade crossing, the easterly option would be more desirable as it is at an existing street intersection where motorists are more likely to anticipate conflicting vehicular and pedestrian movements. For a grade-separated crossing, the westerly location would be more desirable because there is an additional 25 feet of right-of-way (R/W) width to work with and fewer complications for positioning connecting ramps than near the intersection.

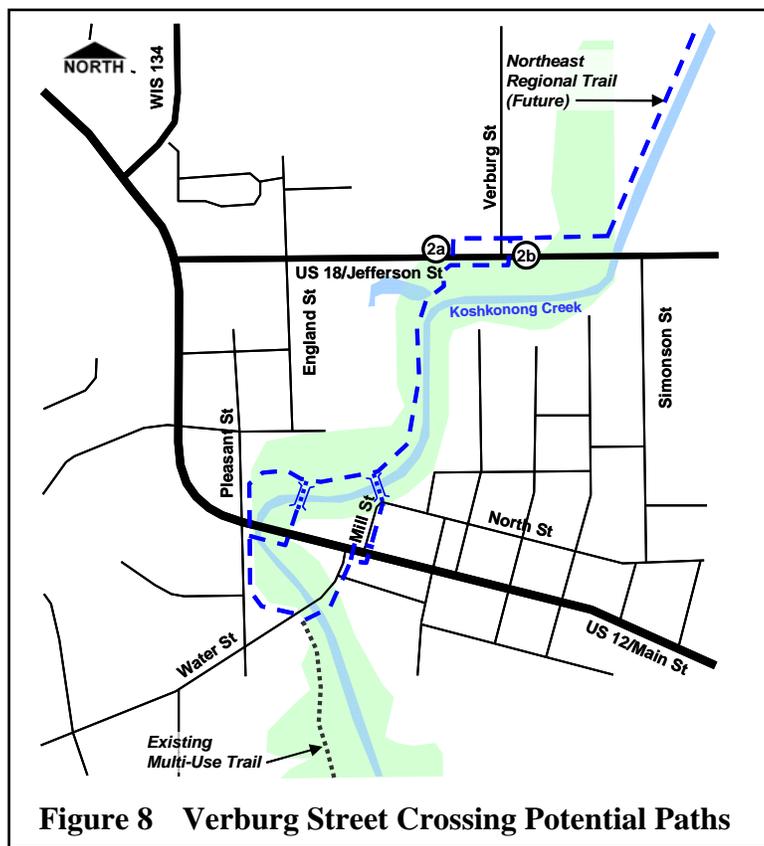
This crossing would provide a central connection between the existing southwest Multi-Use Trail and the future northeast regional trail, both shown in Figure 8, through the extension of a new trail system along the west bank of the Koshkonong Creek.

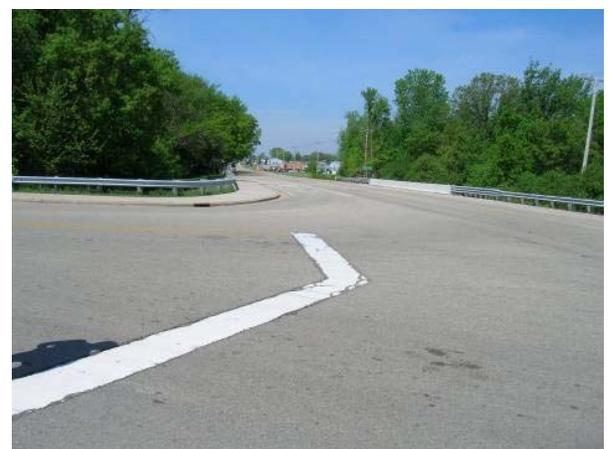
Figure 9 US 18 and Simonson Street

There is a potential north-south pedestrian crossing at US 18 and Simonson Street. The picture in Figure 9 was taken from the southeast corner of the intersection, looking west.

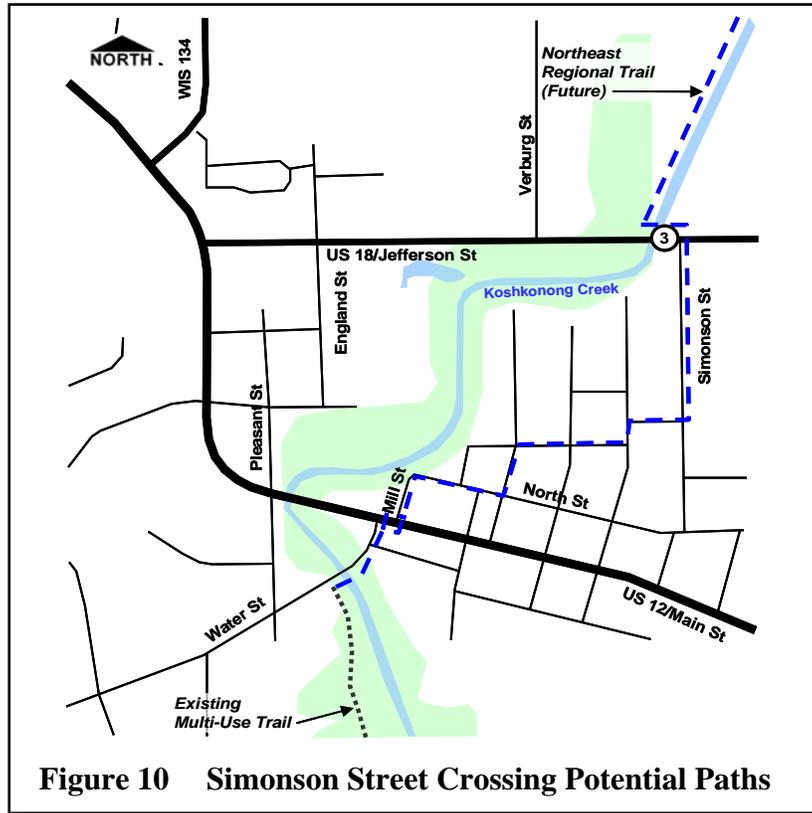
This crossing provides an eastside connection between the existing southwest Multi-Use Trail and the future northeast regional trail by using an internal village pathway system along existing village streets (shown in Figure 10).

Currently, there are no pedestrian facilities on any of the approaches for this crossing. On-street bike lanes and off-street bike paths and/or sidewalks could be provided on Simonson Street. On-street lanes would require restrictions for on-street parking on Simonson Street. Off-street improvements would result in short term disruption to the public terrace areas in front of the adjacent parcels. Steep existing terrace grades along the east side of Simonson Street would require extensive use of landscaping walls.

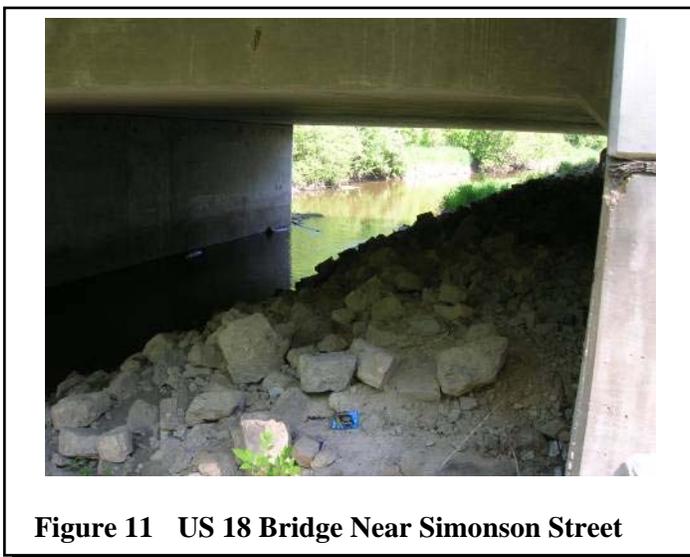
Figure 11 US 18 Bridge Near Simonson Street

The existing US 18 bridge over Koshkonong Creek at this location would allow for installation of a below-grade pedestrian/bike crossing, thus avoiding the cost and disruption associated with installation of a precast concrete box segment. As a minimum, such a crossing would be a 10-foot-wide paved path beneath the existing bridge along the west side of the creek with retaining walls and railings on the creek side to adjust the existing abutment areas beneath the bridge. Ramps connecting the paved path to the surface would need to be provided. The existing under-bridge conditions are shown in Figure 11.

The pathway provided beneath the bridge will be within a few feet of the normal creek elevation. During high flow periods in the creek, it is likely this path will become submerged inaccessible. These situations would not be frequent occurrences, but they would limit the use of this crossing. To accommodate users who are either uncomfortable with the grade-separated crossing, or who have found the grade-separated crossing inaccessible because of high water conditions, an at-grade crossing should be included with the grade-separated crossing, as shown in Figure 12.

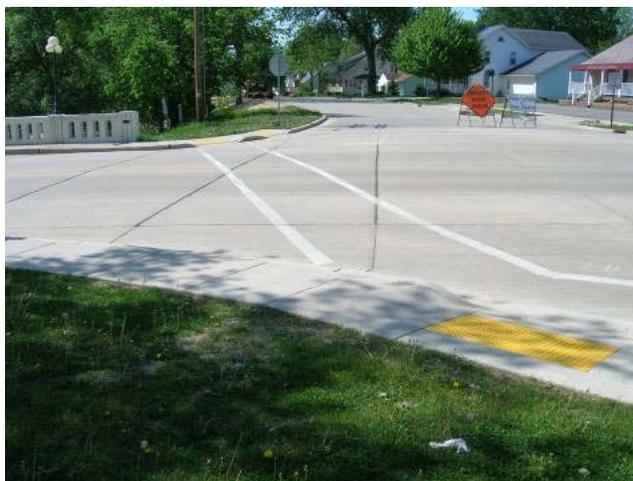
Figure 13 US 12 and Pleasant Street West Option Location

There are two potential north-south pedestrian crossing options near US 12 and Pleasant Street. The existing crosswalk at the potential west crossing is shown in Figure 13, facing south. There is also an east option for an at-grade crossing on the other side of Koshkonong Creek to the east of this intersection as shown in Figure 14.

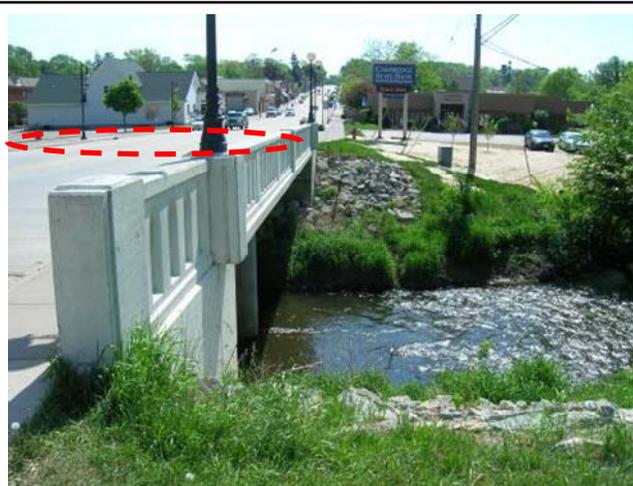
Figure 14 US 12 and Pleasant Street East Option Location

The easterly crossing would be approximately 100 feet east of the bridge over the Koshkonong Creek. The westerly option provides a somewhat more direct route from the future path location along the west bank of Koshkonong Creek. For an at-grade crossing, the westerly option would also be more desirable as it is at an existing street intersection where motorists are more likely to anticipate conflicting vehicular and pedestrian movements.

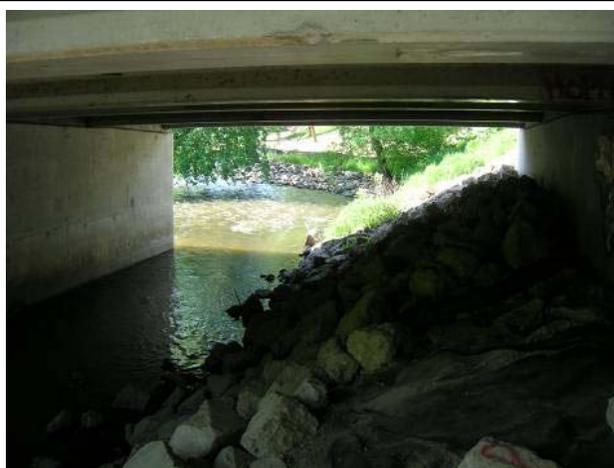
Figure 16 US 12 and Pleasant Street Below-Grade Option

The existing US 12 bridge over Koshkonong Creek at this location would allow for installation of a below-grade pedestrian/bike crossing on the west side of the creek. The existing under-bridge conditions are shown in Figure 16. As a minimum, such a crossing would be a 10-foot-wide paved path beneath the existing bridge with retaining walls and railings on the creek side to adjust the existing abutment areas beneath the bridge. Ramps connecting the paved path to the surface would need to be provided. A steep slope to the south of the bridge and

large oak trees present significant challenges for siting a pedestrian trail on the east side of Pleasant Street. Additional retaining walls and other measures would have to be provided to construct a path in this location. It should be noted that the proposed pathway beneath the bridge will be within a few feet of the normal creek elevation. During high-flow periods, it is likely this path will become submerged and inaccessible. These situations would not be frequent occurrences, but they would limit the use of this

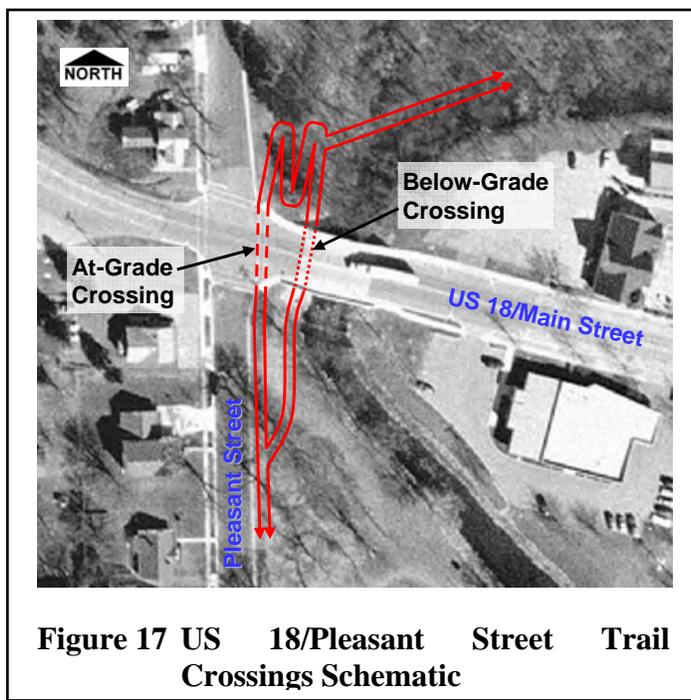
Figure 17 US 18/Pleasant Street Trail Crossings Schematic

crossing. To accommodate users who are either uncomfortable with the grade-separated crossing, or who have found the grade-separated crossing inaccessible because of high water conditions, an at-grade crossing should be included with the grade-separated crossing as shown in Figure 17.

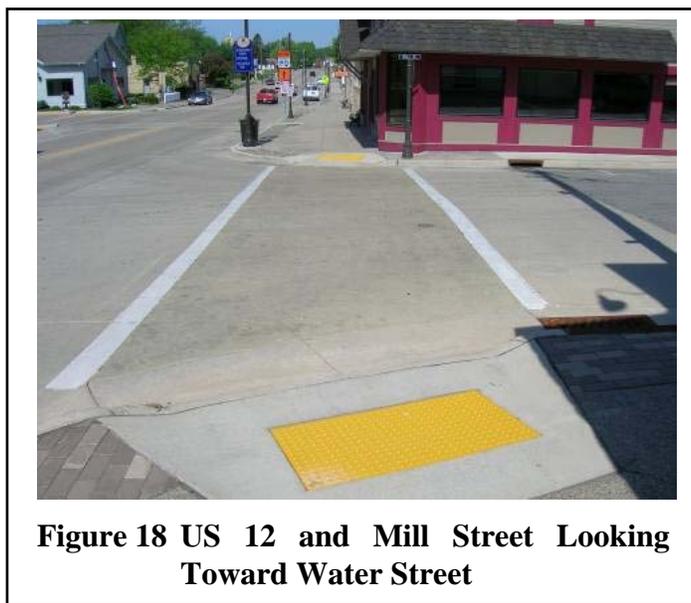
Figure 18 US 12 and Mill Street Looking Toward Water Street

There are two potential north-south pedestrian crossing options along US 12 at Mill Street and Water Street. Both crossings would use existing crosswalk locations, and connect to the trails in the same places. Figure 18 shows the existing pedestrian facilities of Mill Street and US 12, facing west along US 12.

Below- and above-grade crossings would not be feasible at this location, as there is insufficient space for providing connecting ramps.

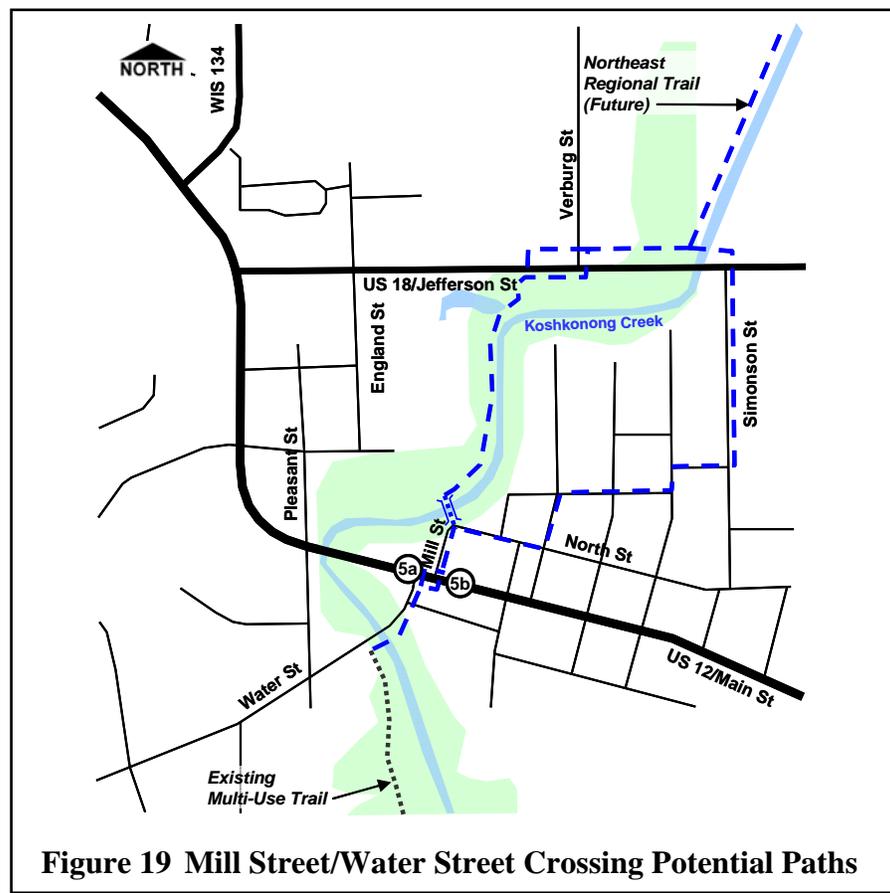
This crossing provides a central connection between the existing southwest Multi-Use Trail and the future northeast regional trail by using an internal village pathway system along existing village streets or via a path on the west side of Koshkonong Creek as shown in Figure 19.

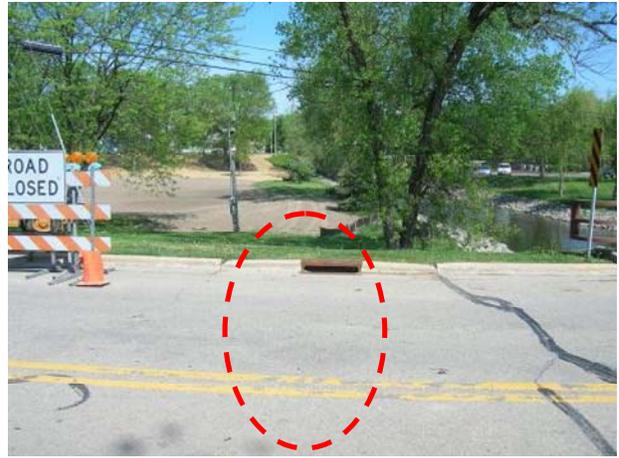
Figure 20 Potential Water Street Crossing Location

Potential pedestrian crossings along Water Street were evaluated. Figure 20 shows the approximate location of a north-south crossing of Water Street looking north.

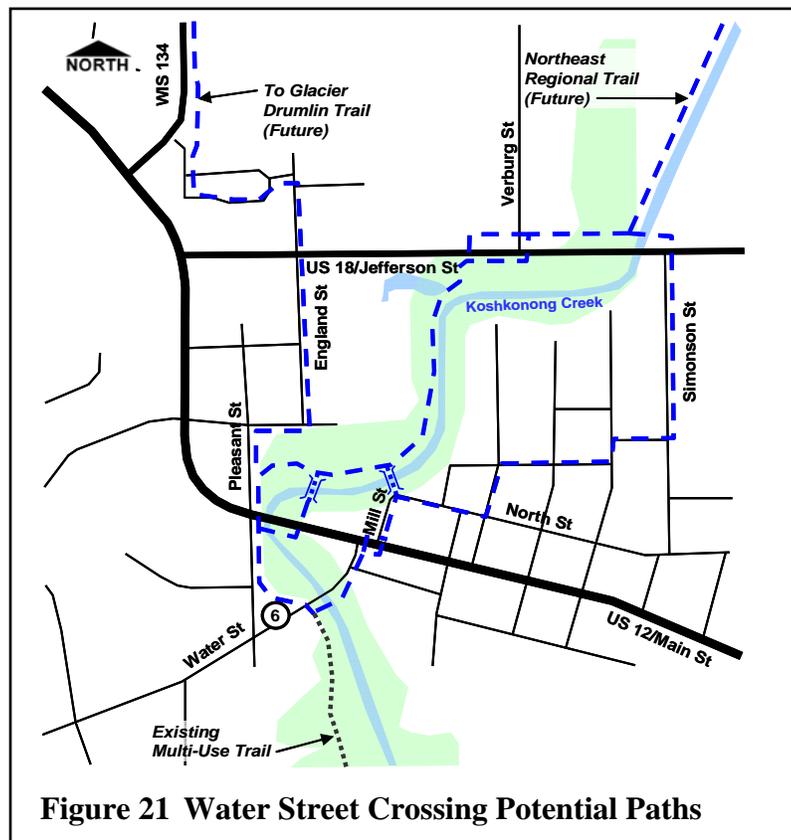
Figure 21 Water Street Crossing Potential Paths

This crossing location would directly connect with an existing cross-county ski and bicycle trailhead located on the west side of Koshkonong Creek, to the south of the bridge. There are also currently few connections to the park area across Water Street from the trailhead. These trails are shown in Figure 21.

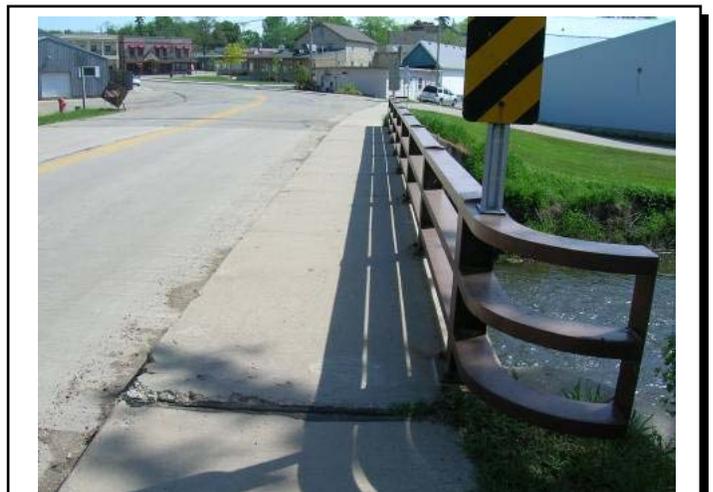
Figure 22 Existing Water Street Bridge

The existing bridge over the Koshkonong Creek, shown in Figure 22, could be utilized as part of the pedestrian trail; however, it would need enhancements if chosen for the pedestrian crossing. The bridge railing is too low to the ground to safely accommodate pedestrians and bicyclists. Widening the sidewalk on the bridge may also be necessary.

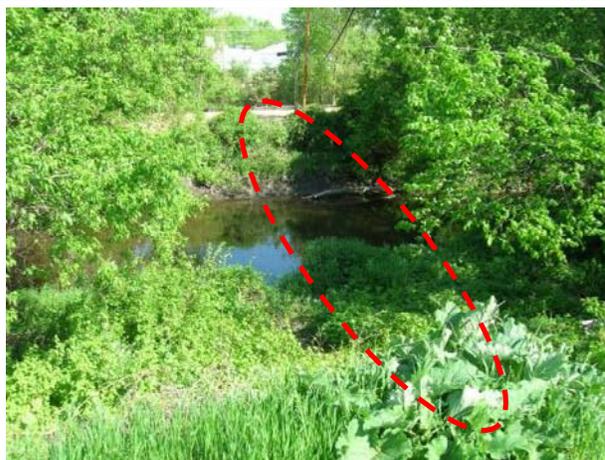
Figure 23 East Potential Pedestrian Bridge Location

The potential for a pedestrian bridge over Koshkonong Creek connecting to Mill Street was evaluated. The picture in Figure 23 was taken near the corner of Mill Street and North Street, looking north.

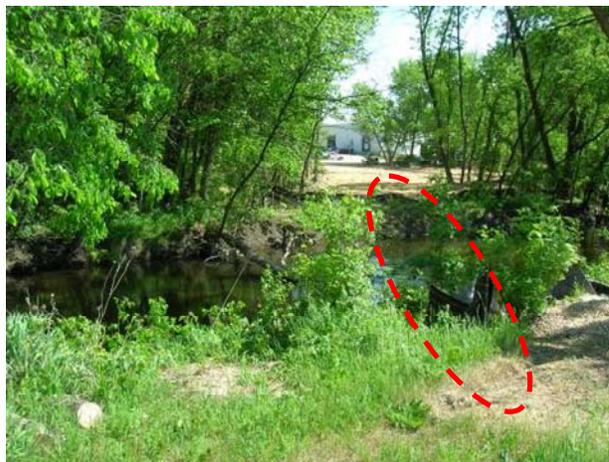
Figure 24 West Potential Pedestrian Bridge Location

The west location for a potential pedestrian bridge across the Koshkonong Creek was also evaluated. This bridge would be located to the east of the US 12 bridge over the creek and to the north of a parking lot. Figure 24 indicates the existing terrain at the approximate location of a pedestrian bridge.

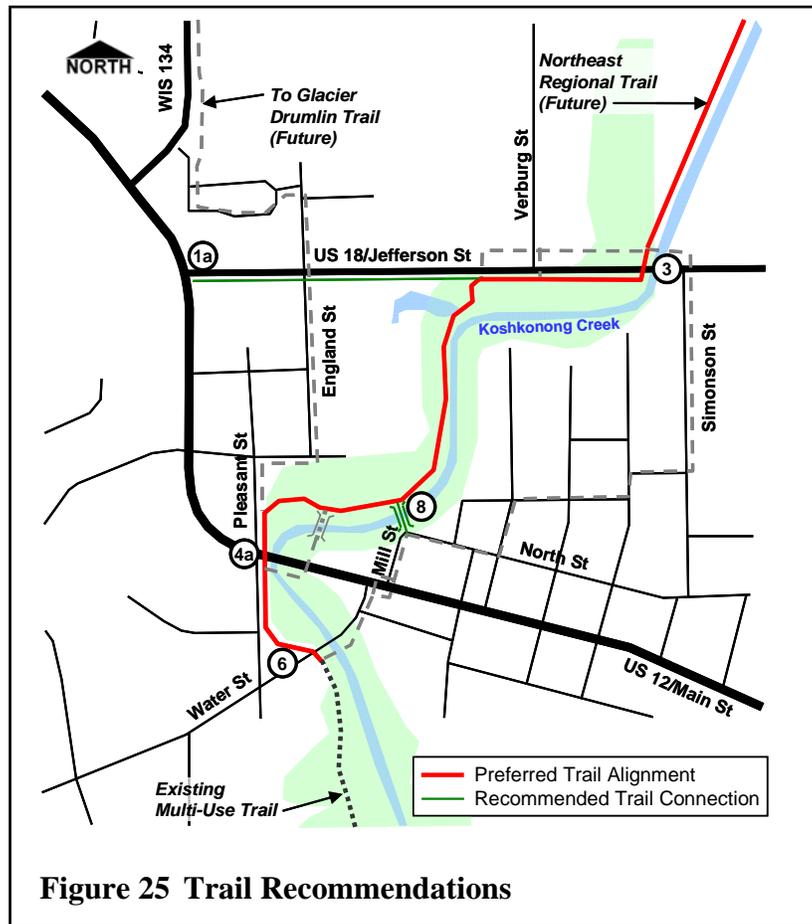
Given the more centralized location, the enhancements to safety, mobility, trail environment, and minimal impacts to existing private properties, we recommend that the Village pursue development of the central trail system depicted in Figure 25.
